Manhole Inspection Summary

Manhole # S29YY1006MH

Location Address: **501 COTSWOLD RD** Cross Street: **AMBERLY AVE**

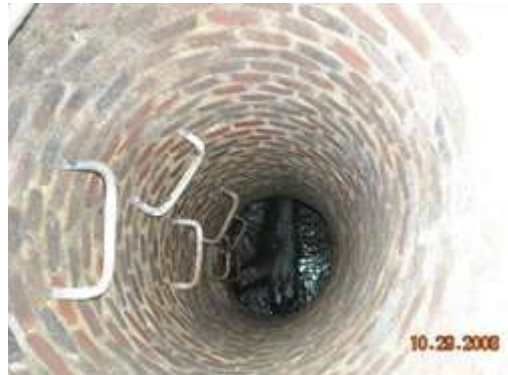
Top View

Adjustment and Barrel infiltration.
Corroded steps. Evidence of surcharge -
Bench debris.

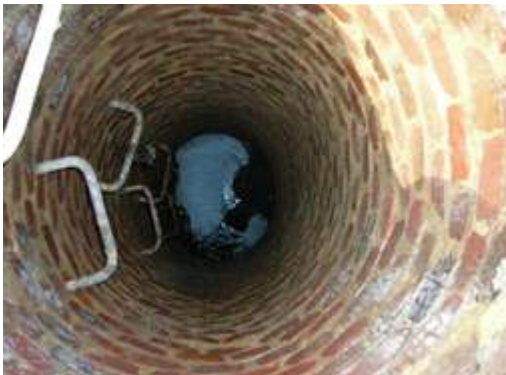
Top View

Active Surcharge - 1st visit.

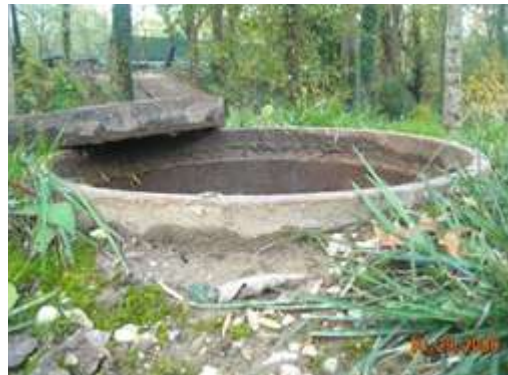
Defect

Above grade.

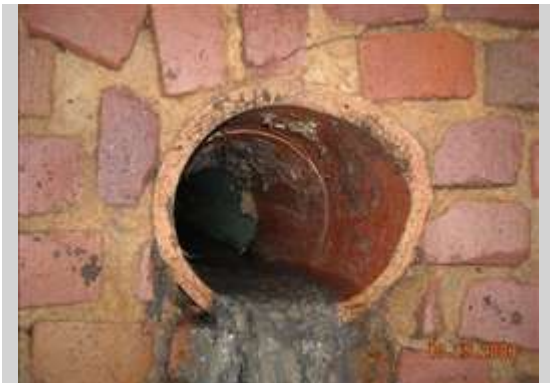
8 in. Circular Gravity Sewer Pipe In @ 6 O'Clock

Deposits: ☐ None ☒ **Mud** ☐ Sludge ☒ **Debris** ☐ Grease

Silt Depth: **4** (in.) Deposits Extent: **Heavy**

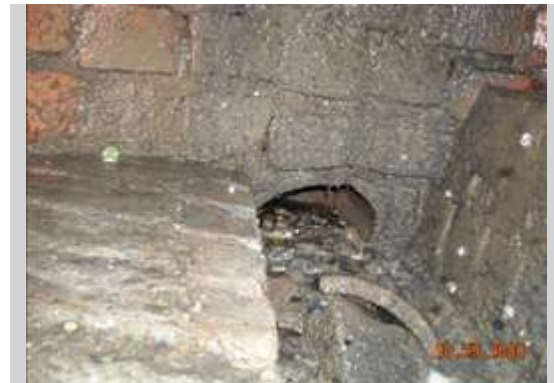
Drop In @ 6 O'Clock

Drop Condition: **Partly Clogged**

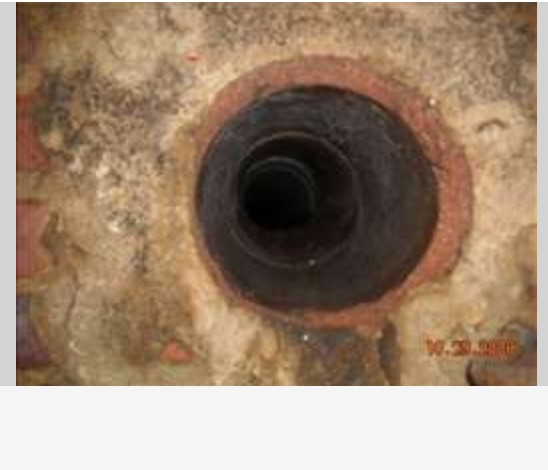
Pipe In @ 9 O'Clock

Infiltration: **None** Pipe Seal Cond: **Roots**
